**KOOTENAI DEVELOPMENT IMPOUNDMENT DAM
DECEMBER 2010 ROUTINE OWNERS INSPECTION**

Prepared for: The Remedium Group

Prepared by: Kurt Hafferman, P.E.

Inspection Date: January 07th, 2011
Report Date: January 11th, 2011

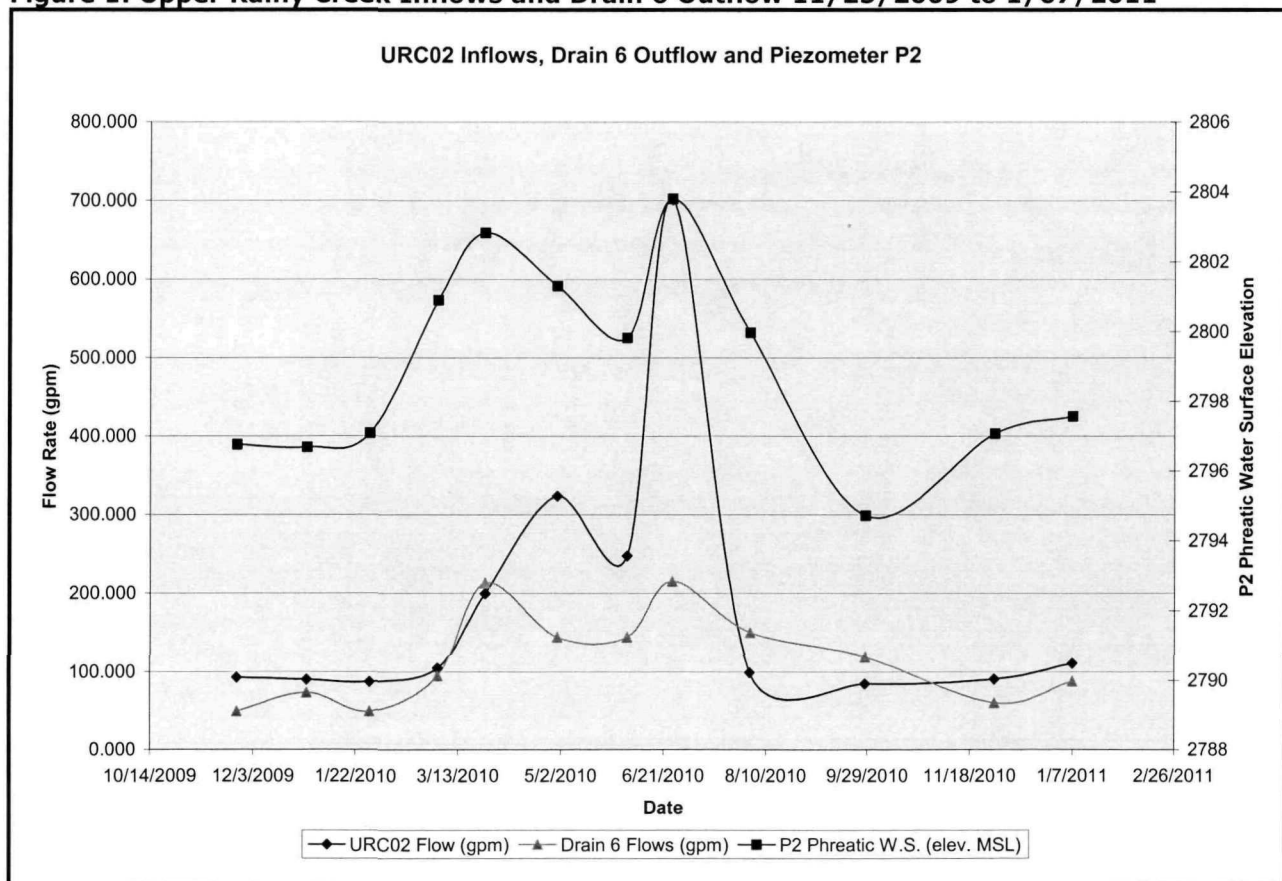
Figure 1: Upper Rainy Creek Inflows and Drain 6 Outflow 11/25/2009 to 1/07/2011

Drain 6, the main drain at the toe, increased flow from 60.1 gpm to 87.9 gpm, an increase of 27.8 gpm, or 46.3% since November measurements. The increase in flows follows flows that were recorded during last month's (November 2010) inspection as being lower than expected. The drain 6 flows recorded are also slightly higher than the same time last year. The higher readings correlate to the increase in snow and precipitation from the same time last year. A graph of the Rainy Creek inflows, piezometer P2 and drain 6 outflows with a comparison from November 25th of 2009 to this inspection is shown in Figure 1 below. As can be seen, flows were stable in December of 2009 and are stable to slightly rising in 2010.

Although it is not unusual to have an increase of inflows, a rise in piezometers and an increase in drain flow in December is unusual in that it has not been noted in any of the other previous years data. Typically all we see in December are falling inflows, piezometers and drain flows. Drain 6 flows and piezometers will be checked with special attention next month. We do anticipate stabilized readings on the inflow next month and stabilized to slightly falling piezometers with a slight decrease in Drain 6 flows next month.

None the less, a review of the graph above indicates we have arrived at typical low drain flows for this time of year. Drain 6 and URC-02 show elevations readings similar to December 2009 readings and, as such, we expect to see stabilized flows in and out of the reservoir in the coming winter months and we expect to see piezometer P2 and the other 'wet' piezometers (those that exhibit consistent rising and falling water surfaces) stabilize or drop during next months readings.

No maintenance issues at this time. Continue to closely monitor inflow, piezometer readings and drain 6 outflows for fluctuations.

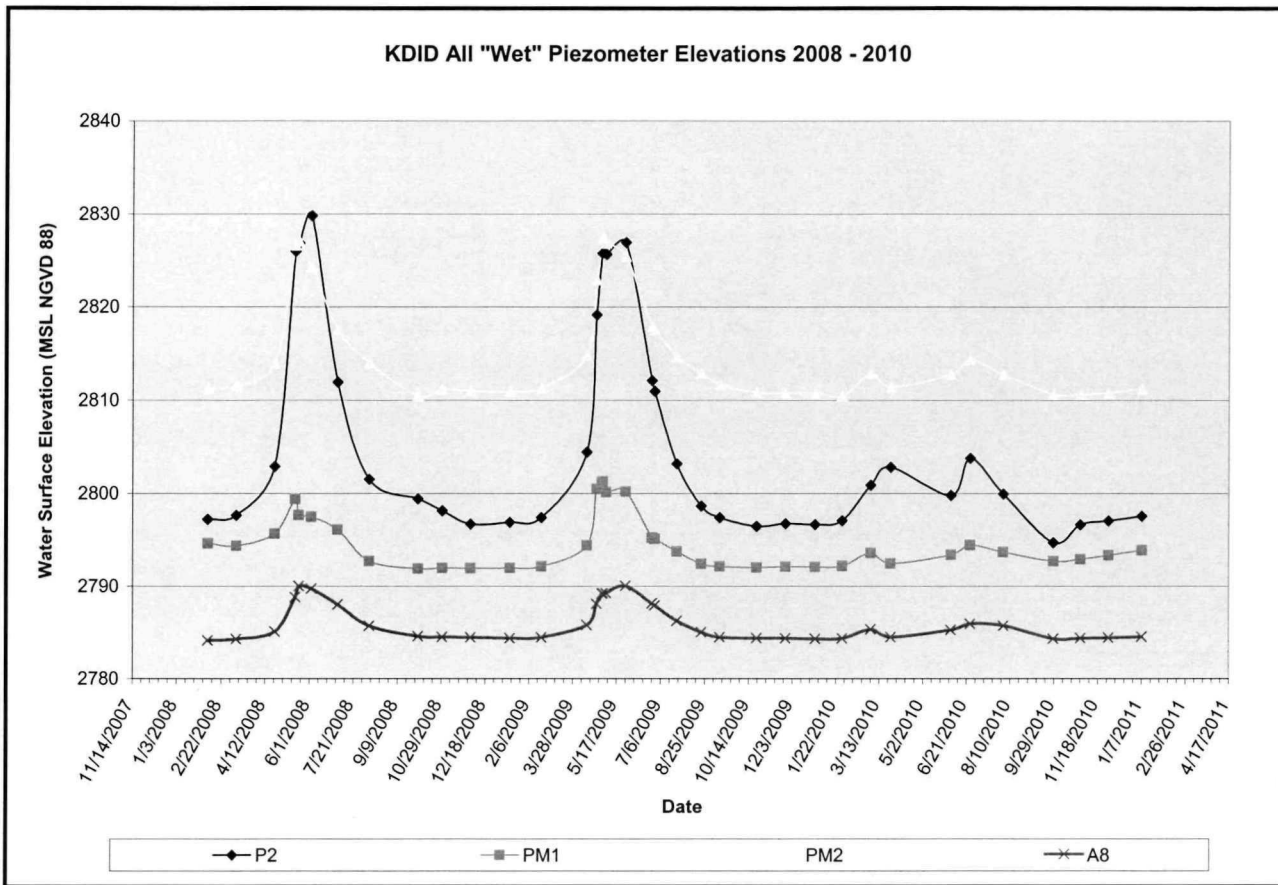
Figure 3: Piezometer Elevations 2008-2010

The double rise that is shown in the May and July Figures 2 and 3 above are not typical in any of the monitoring records for this time period that BHI has. They are assumed to be weather related as there was a low snowmelt/runoff in late May and then we had a wet and rainy late July and early August.

The graph above shows that all piezometers are at typical levels for this time of year; lower than the peak of the year. We observed the four wet piezometers all seem to follow the general pattern of rising and falling. We note that the over all peak water surface elevations are low to much lower than other years although this has been a normal to slightly higher than normal water year.

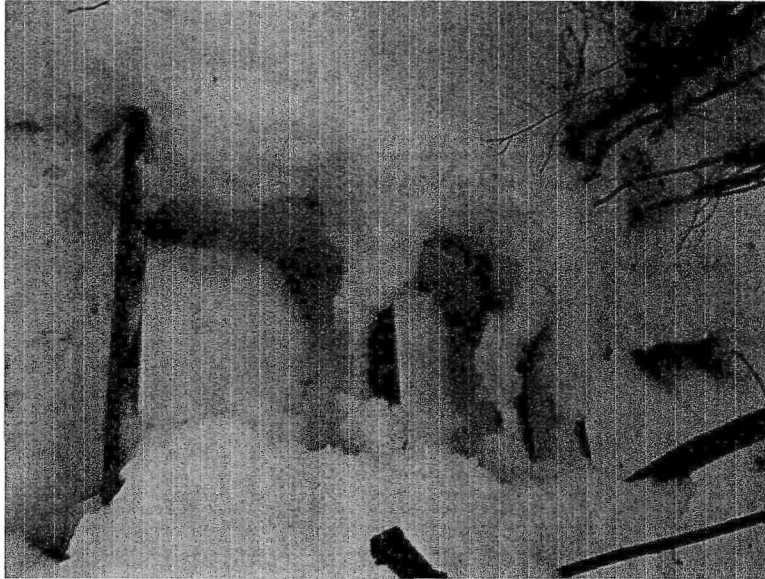
- a. The Fleetwood Creek Flume was froze over and no gauge reading could be taken. Flows were low and appeared to be going around the Flume.
 - b. The flow in Upper Rainy Creek has increased. The URC-02 Flume was read and the gauge height was recorded at 0.35 feet.

Fleetwood Creek Flume - Frozen

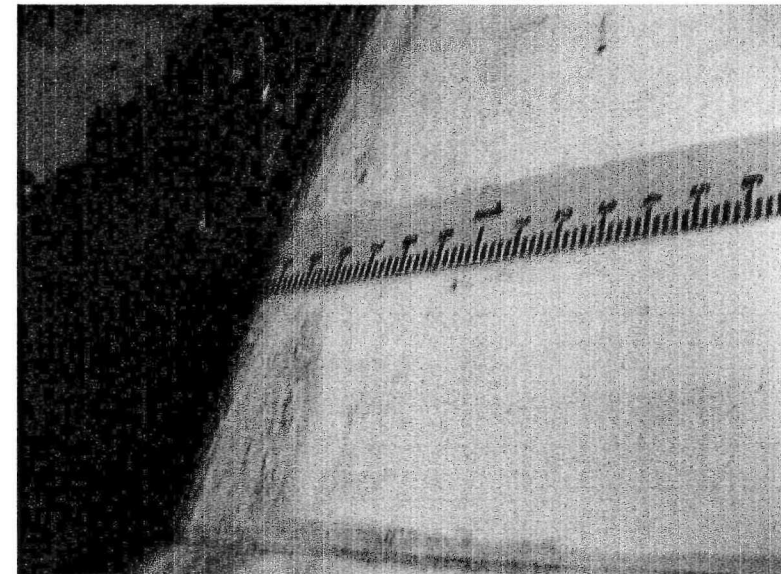
URC-01 Gauge – Low Flow

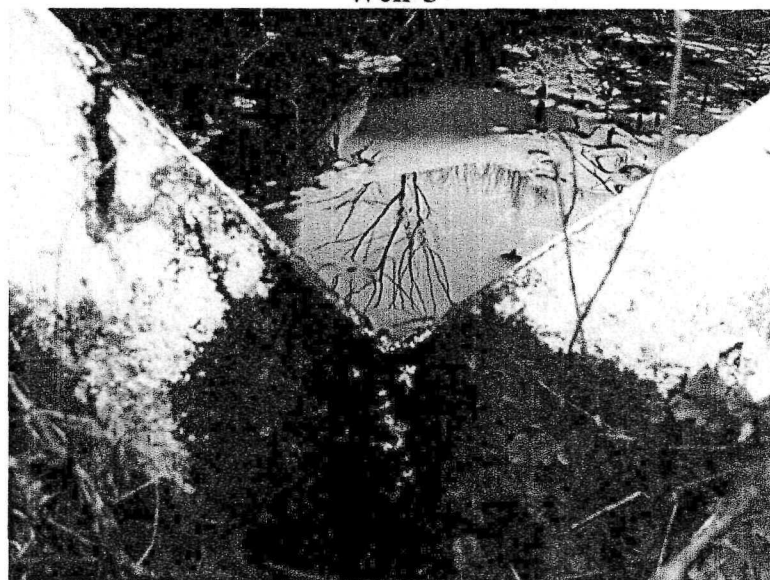
Weir 5 Very Low Flow

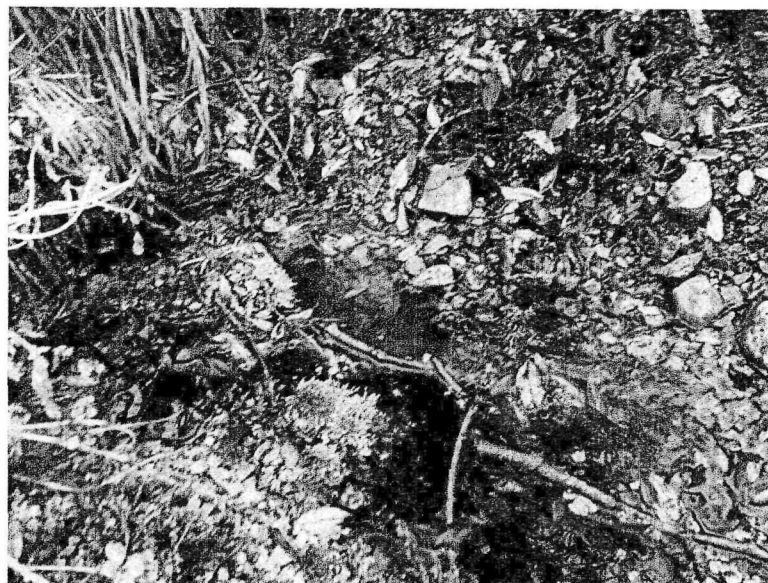
8. Drains were inspected and the flows in the drains and stream channel below the drains were recorded. Drain 6 had an increase of flows while drain 12 decreased flows. Drain 5 was again recorded at very low levels. Seepage was noted below Drain 7, but no more than has typically been seen. A graduated cylinder was used to check for sedimentation in the water at each drain; none was noted. Drain flows were all clear and steady.

Seepage Below Drain 7

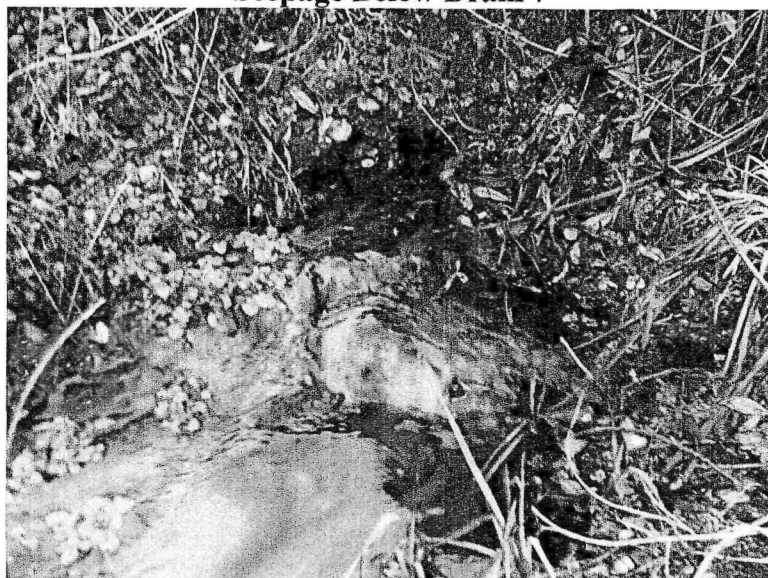
More Seepage Below Drain 7

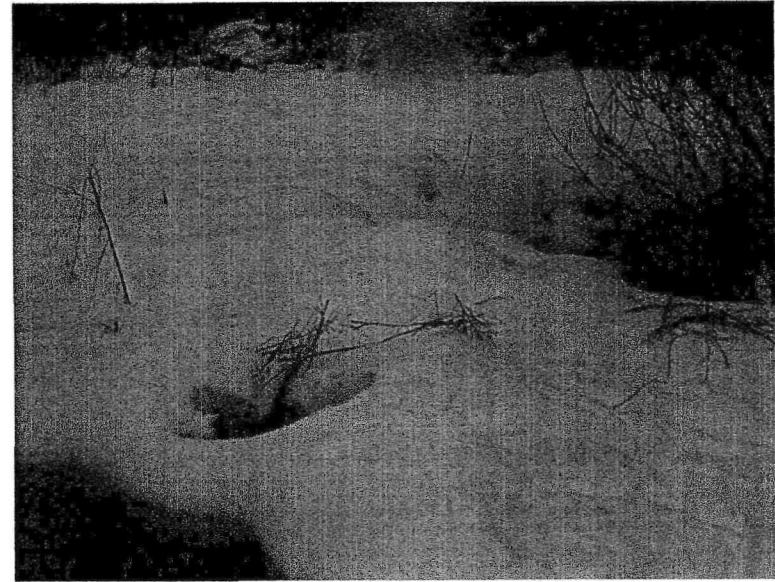
LRC-02 Covered with Snow
